UNITED STATES COAST GUARD

**MARINE BOARD OF INVESTIGATION INTO THE
CIRCUMSTANCES SURROUNDING THE SINKING OF THE**

F/V KATMAI

**IN THE AMCHITKA PASS, NORTH PACIFIC OCEAN
ON OCTOBER 22, 2008, WITH MULTIPLE LOSS OF LIFE**

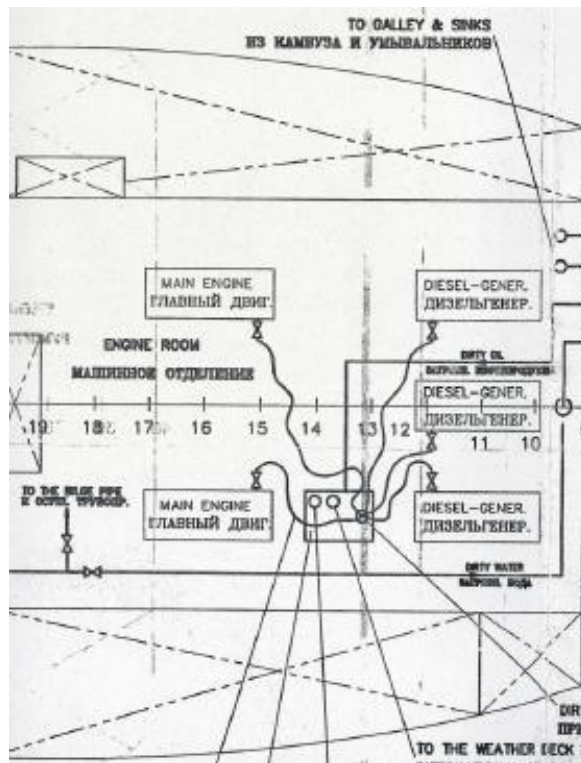
Figure 4: F/V KATMAI Engine Room

A review of the emails transmitted during the vessel's voyage using the SkyMate[®] VMS revealed that the GMC 6-71 75 KW generator was inoperable. The Captain and vessel operations manager indicated that the two remaining generators would have been sufficient to handle all electrical loads on the F/V KATMAI.

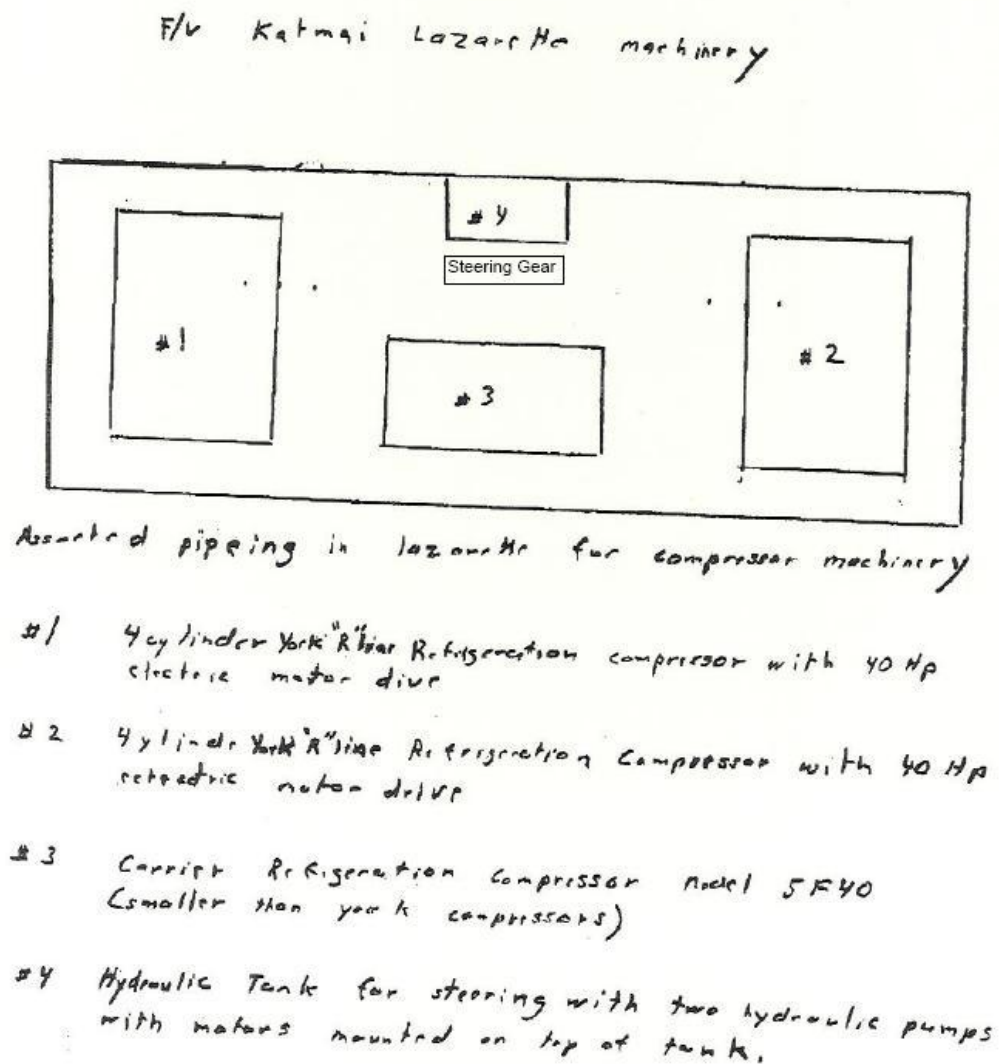
Figure 7: Layout of F/V KATMAI Lazarette (Drawn by Vessel Operations Manager)

Testimony indicated that there may have been a 1½" – 2" drain in the forward bilge on the centerline of the lazarette that could have permitted water to drain directly into the engine room. This drain may not have worked properly or may have been plugged through a previous modification that prevented water from draining from the lazarette into the engine room. A previous engineer on the vessel also indicated that the lazarette bilge drain was tied into the engine room bilge system which would have permitted water in the lazarette bilge to be pumped out from the engine room.

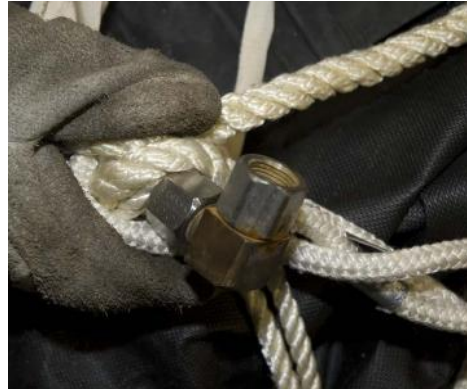
Inflation Hose Bottle Connection

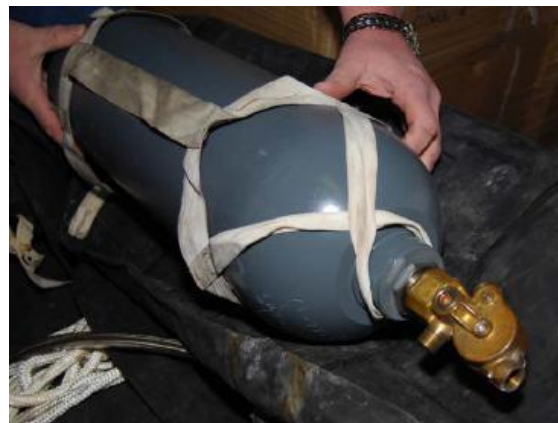
Sample Harness with Cylinder Inserted

The cylinder harness on the recovered liferaft was intact. In the left picture above, the right end of the harness that would permit the cylinder to be inserted or removed was also tied together as would have been done after a cylinder had been inserted into the harness prior to packaging of the liferaft. The left end of the harness shown in the left picture would have been looped around the neck of the cylinder as shown in the right picture. The only way the cylinder could have fallen out of the harness would have been improper installation or if the cylinder became disconnected from the inflation hose to permit the cylinder head to slide out of the loop and thus allowing the cylinder to slide out of the harness.

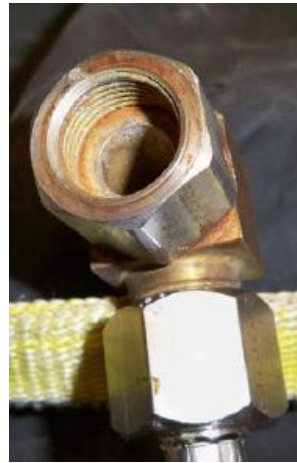
90 Degree Swivel Elbow

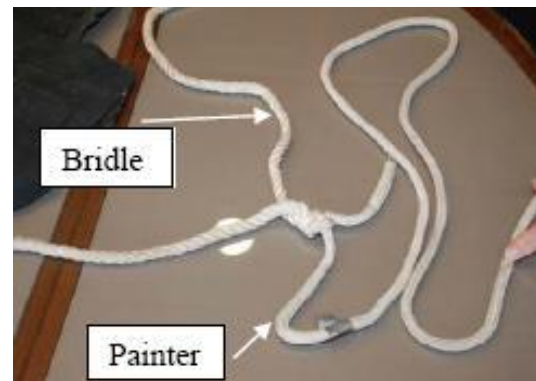
Liferaft Bridle and Painter

The picture above shows the bridle and painter from the recovered liferaft. A 12" long 1/8" diameter nylon cord should have been installed at least 60" from the bridle attachment. There was one location on the painter where it appeared that a line had passed through to connect to the inflation cable. However, it cannot be determined if a nylon cord was installed in the painter during the most recent servicing in December 2007. If the nylon cord was not installed properly and attached to the cylinder lanyard, then the liferaft could not have been deployed by pulling the painter. The nylon cord most likely came loose as the painter was tossed around in the rough seas.

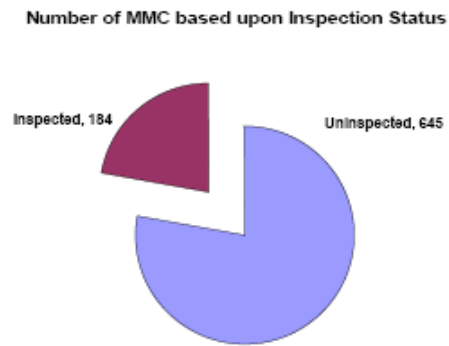
Figure 18: MMC vs. Inspection Status

As shown in Figure 18, uninspected vessels are over 3 times more likely to be involved in a major marine casualty.

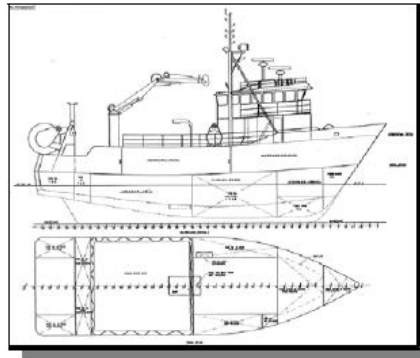
Figure (1). Profile and Plan View of KATMAI from 1996 Stability Report

Our model's hydrostatics were compared to the "as inclined" waterline from the Schwitters/Stevenson report using the freeboards and heeling moment from the 1996 stability test. Our model had the same lightship displacement, longitudinal center of gravity (LCG) and vertical center of gravity (VCG) to within 0.5% of the values listed in the report. Figure (1) shows the profile and plan view of the vessel from the Schwitters/Stevenson report and Figure (2) shows the profile, plan and orthogonal view of our model.

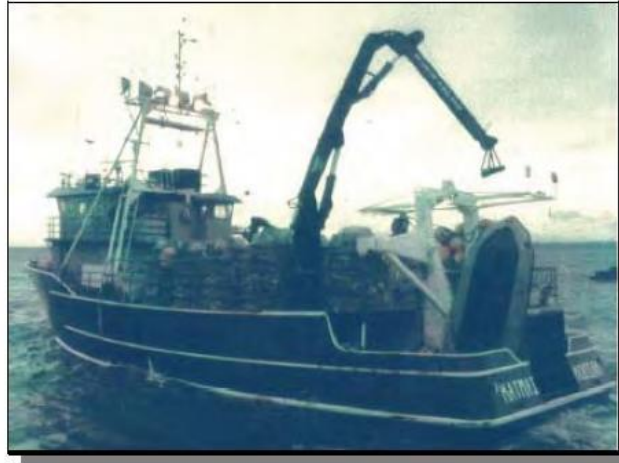
Figure (3). KATMAI with Pots on Deck and Spool Removed

As part of our review of the material provided with reference (a), pictures of the vessel from as recent as 2007 showed a different wind profile than developed in the model shown in Figure (2). In order to more accurately assess the vessel's stability, an additional wind profile was added to the model equal to the height and length of the pots stored on the fishing deck. We also removed the trawling spool wind profile from the model. Additionally, a tank, with a height equal to the aft bulwarks, was added to our model to simulate the entrapment of water on the aft deck; this was necessary to evaluate the water on deck criteria of 46 CFR 28.565. Figure (3) shows a picture of the KATMAI representing these differences. Figure (4) shows the model from the same aspect with these changes applied. While the wind profile in the model is not identical to Figure (3), it is a more accurate than the model from Figure (2) and provided us with a more realistic assessment of the KATMAI's stability at the time of the casualty.

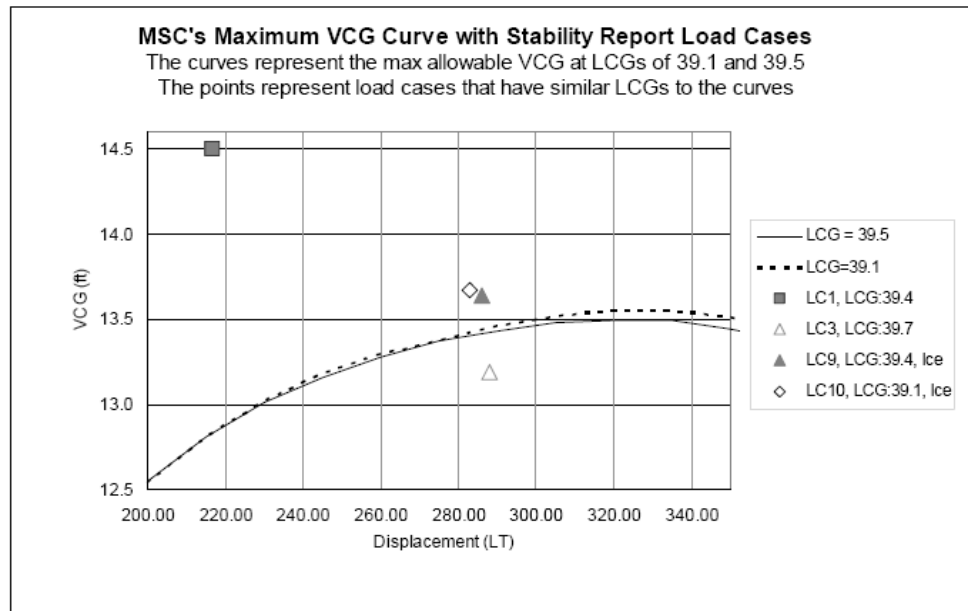
Figure (6). Max VCG curve with vessel LCGs of 39.1 and 39.5

As part of our intact stability review, maximum VCG curves were generated. A maximum VCG curve shows maximum allowable VCGs for the vessel over a range of displacements. Because the shape of maximum VCG curves is dependent on trim, separate curves were generated for different LCGs. A composite set of curves for the three intact stability criteria evaluated by our office was generated by finding the most restrictive criteria for each displacement/LCG combination. Figure (6) and (7) show various maximum VCG curves at different LCGs, with the points in the figures representing various loading conditions from the Schwitters/Stevenson report. Furthermore, the comparison of the pre-casualty condition to the maximum VCG curves is discussed in section 3.6 below.

Based on our review, several of the conditions did not meet the intact stability requirements evaluated, specifically LC 1, 8, 9 and 10. In general, the limiting criteria were the Severe Wind and Roll requirements contained in 46 CFR 28.575. Adding the extra sail area to model the pots on the fish deck significantly reduced the maximum allowable VCG. Had the sail area from the pots not been included in the computer model's wind profile, LC 8, 9 and 10 would have met the requirements of 46 CFR 28.575.

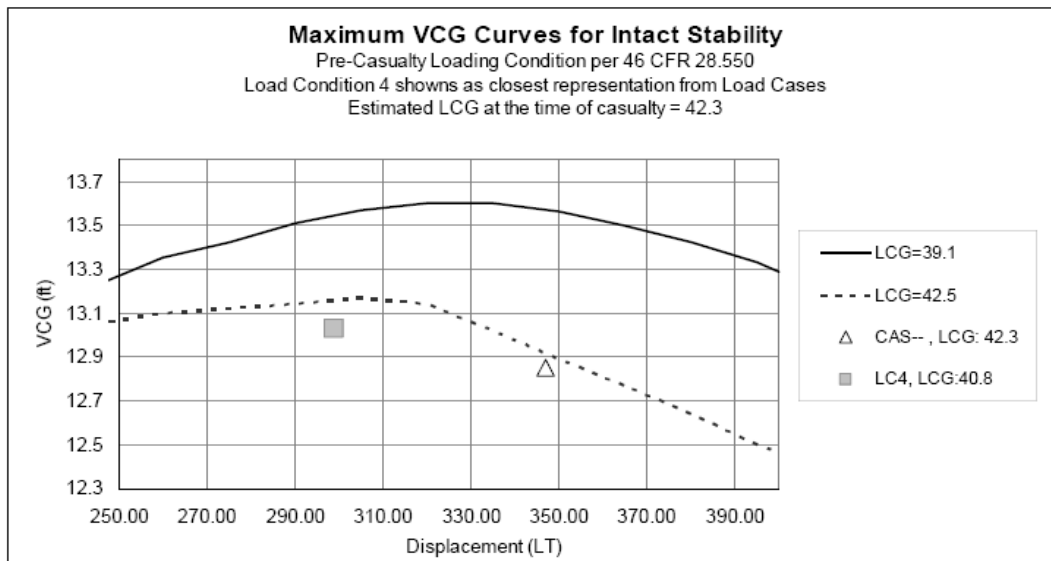
Figure (8). Range of Stability

In our review, we noted that in all eleven loading conditions from the Schwitters/Stevenson report, the vessel had forward trim. Even the fuel burn sequence in Operational Limitations in Part I of the report was based on the vessel having forward trim as fuel was to be burned from the #3 tanks then the #5 tanks. In reference (a) however, it was reported that the master ordered the transfer of fuel from the #5 tanks to the #3 tanks, contrary to the stability guidance in the Schwitters/Stevenson report. In load condition 4 the vessel has 1.5 feet of forward trim. In the vessel's estimated pre-casualty condition above, even after shifting the fuel from the #5 tanks to the #3 tanks, the vessel only had 0.3 feet of forward trim. Given the aft trim in the pre-casualty condition, it is not surprising that the master wanted to shift fuel from the #5 fuel tanks to the #3 fuel tanks to reduce the vessel's aft trim.

The estimated pre-casualty conditions were outside the range of displacements and LCGs reviewed in the Schwitters/Stevenson report; however, our model showed that the vessel likely would still have met the intact stability limits in Subchapter C.

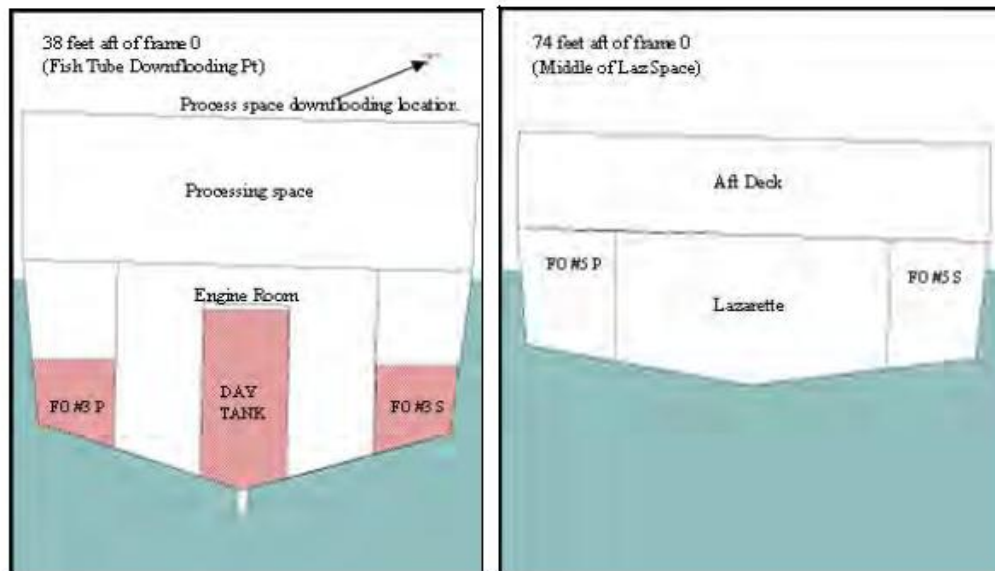
Figure (9). Body Plan Space Description

Figure (9) depicts the compartments on the body plan sections used throughout the remainder of the analysis. These are the primary areas of interest for the flooding scenarios to follow (note the location of the downflooding point into the processing space in the left figure).

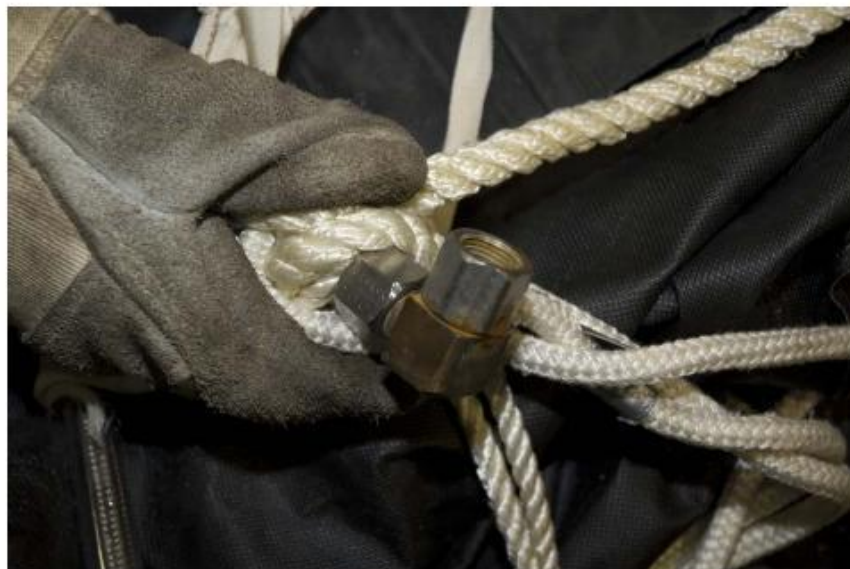
Figures 1, 2, and 3 show the CO₂ inflation hose assembly as found on the life raft when retrieved from the Bering Sea by the fishing vessel *Courageous* about 17 hours after the life raft's deployment during the sinking of the *Katmai*. The life raft did not appear to be inflated when brought on board the *Courageous*. During the life raft's duration at sea, the painter (a rope line that attaches the raft to the vessel and activates the inflation mechanism when pulled) became entangled with the inflation hose as shown in Figures 1 and 2. As evident in Figures 1, 2, and 3, the CO₂ tank was not attached to the inflation hose, nor was it found with the un-inflated life raft. Figure 3 shows the CO₂ inflation hose assembly after removal of the painter.

Figure 2. Close-up of the CO₂ inflation hose fitting, which is typically connected to the inflation valve and CO₂ tank.

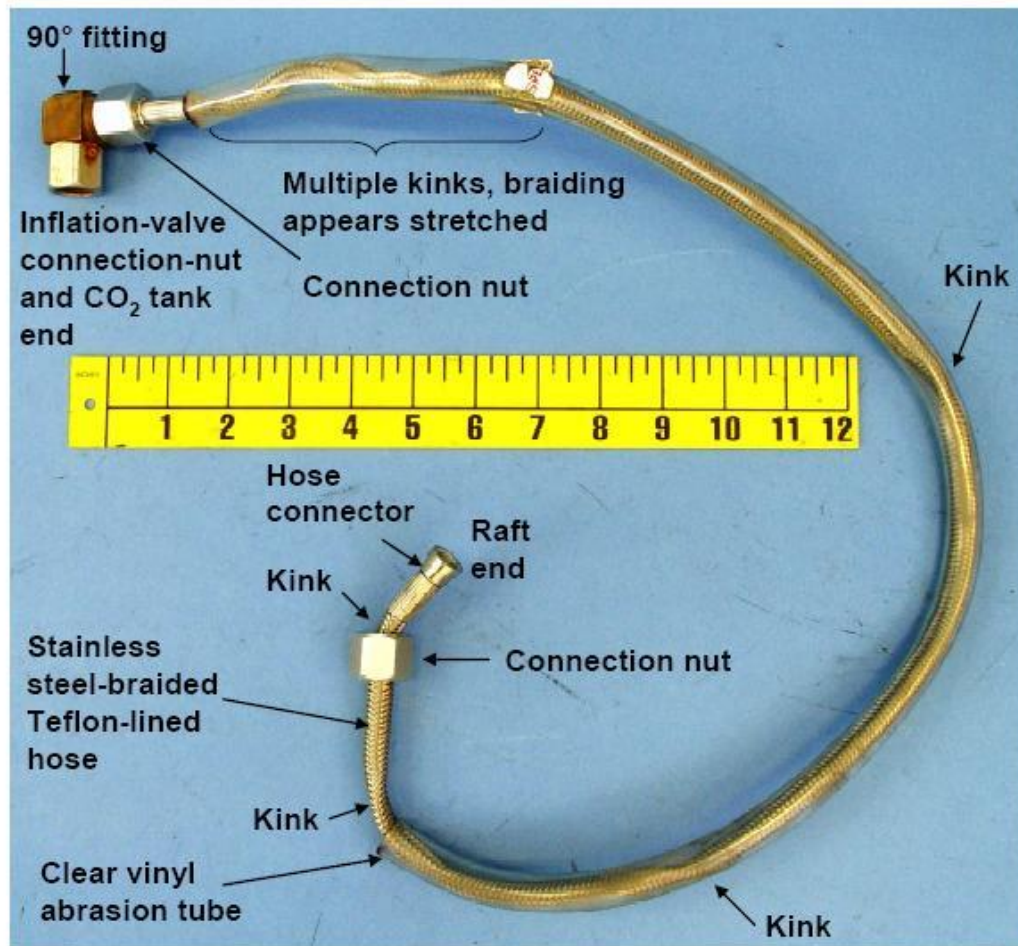
Figure 4 shows the hose and 90° fitting assembly as received by the NTSB Materials Laboratory. According to the Coast Guard Marine Board of Investigation, the hose was supplied by SMR Technologies as drawing number 4RA1174 at a length of 31 inches +/- 0.5 inch. The drawing indicates that the hose is composed of an inner Teflon® liner, an over-braid of stainless steel wire, an outer clear vinyl abrasion tube, and Type 316 stainless steel hose-connector and connector-nut fittings on each end. As shown in Table 1, the

As shown in Figure 4, the hose is kinked in 5 different regions. At the hose end connected to the 90° fitting, there is approximately a 5-inch region with multiple kinks. The braiding in this region shows evidence of stretching (as indicated by distortion of the regular pattern of the braiding). The length of this stretched region is consistent with the longer-than-specified length of the hose.

Figure 4. CO₂ inflation hose assembly as received in the NTSB Materials Laboratory. All critical features are identified in this figure.

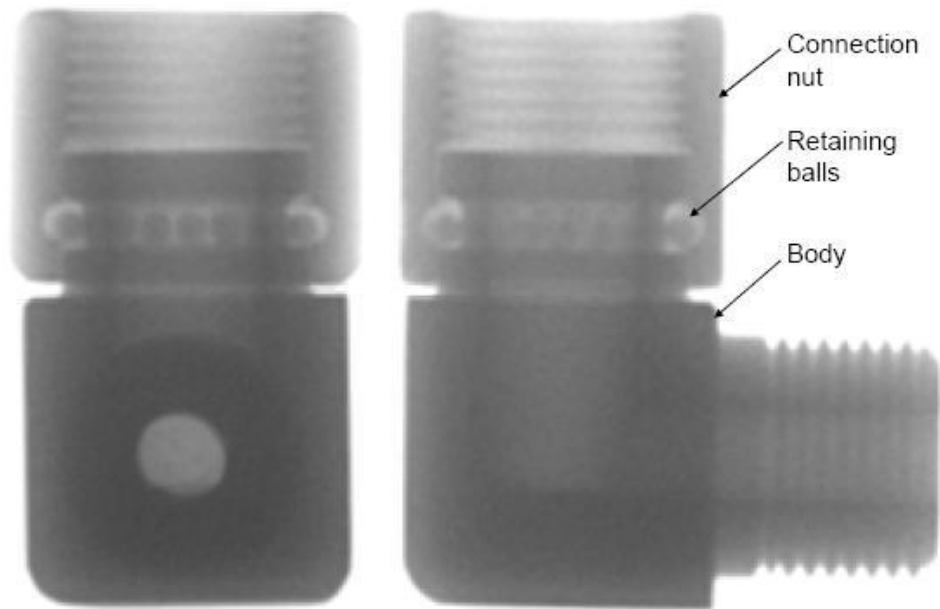
Once removed, the 90° fitting was x-rayed as shown in Figure 7. The inflation-valve connection-nut is mechanically attached to the body through the use of a series of retaining balls. These retaining balls are intended to allow the inflation-valve connection-nut to rotate relative to the body. However, with hand rotation using moderate torsional force, the inflation-valve connection-nut did not rotate freely relative to the body as intended by the design.

Figure 7. Radiograph of the 90° fitting showing the internal features. The connection-nut swivels relative to the body through the use of the retaining balls.
